ENCLOSURE 2 TO AEP-NRC-2014-59

I&M CAP Document AR 2010-1804-10, Root Cause Evaluation Attachment, "Rx Vessel Core Support Lug Bolting Anomalies"

**Root Cause
Evaluation of Unit 1
Rx Vessel Core Support Lug
Bolting Anomalies**

**(AR 2010-1804-10)
March 21, 2010**

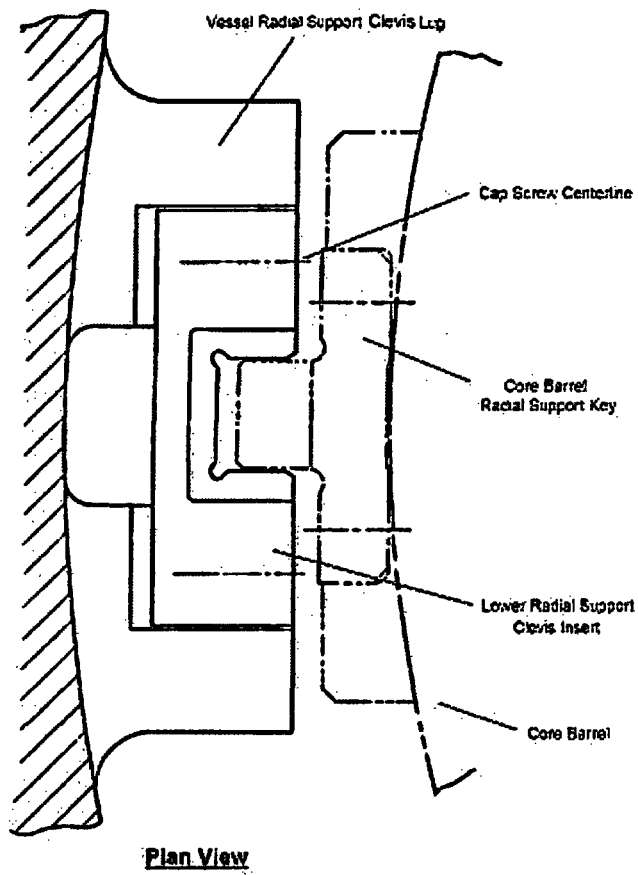
Figure 3: RSK and Clevis Insert Interference

See Figure 3 for the interface between the RSK and the clevis insert. For the D.C. Cook design, each core barrel clevis insert contains eight bolts (cap screws), for a total of 48 bolts. These bolts are restrained from rotation by a welded lock bar at each bolt location. In the event that a bolt fails, the lock bar design captures the bolt and keeps it in place to prevent a loose parts condition. Each insert location also contains 2 dowel pins, for a total of 12 pins. The clevis insert dowel pins provide added, possibly redundant, retention of the insert from long term vibratory motion. The interference fit of the pins keeps the insert from having small displacement slippage in the upward direction over time. They also help to prevent the clevis from sliding upward during core barrel removal. This prevents production of bending stresses in the bolt shanks if the clevis should shift. The clevis insert design and bolts prevent motion in other directions. Table 1 describes the bolt, lock bar, and dowel pin materials and sizes. Figure 4 illustrates the as-designed installation of the clevis inserts at D.C. Cook.

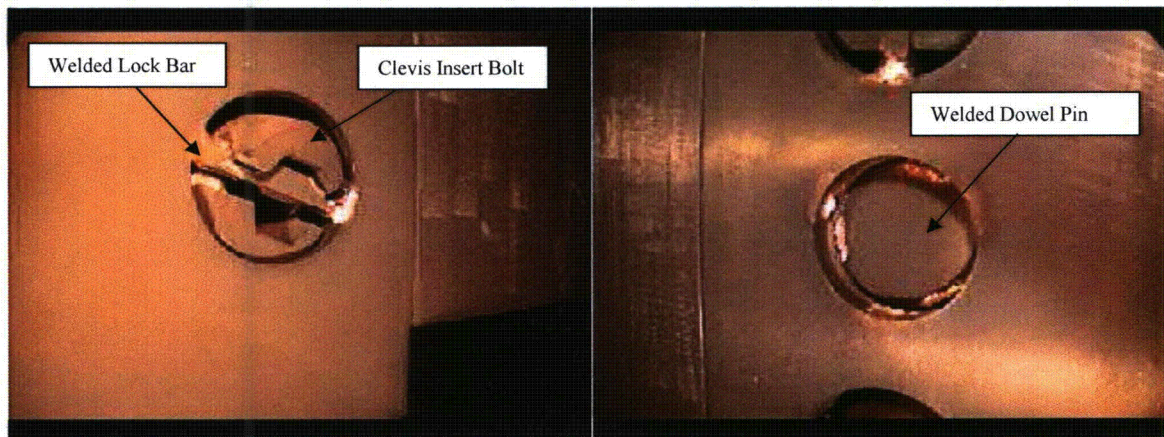
Figure 5: Typical condition of broken bolt (left). Broken dowel pin tack welds (right)

Damage was observed in the LRSS clevis insert bolts. Wear was observed on the lock bars and cap screw heads at a total of seven bolt locations; at five of these locations, the bolt heads were dislodged from their expected locations. Additionally, at one location,

the three tack welds holding the dowel pin in place were noted to be broken. Figure 5 shows an image of a typical broken bolt (left) and the broken dowel pin tack welds (right). Table 2 shows the as-found condition of the cap screw and dowel pin with respect to each clevis location [Exhibit 9].

Developed and implemented a minimum bolting pattern under EC-51640, "RX Vessel Lower Radial Support System (LRSS) Clevis Replacement Bolting for Unit 1," which incorporated an improved heat treatment and an under head radius that reduced peak stresses.

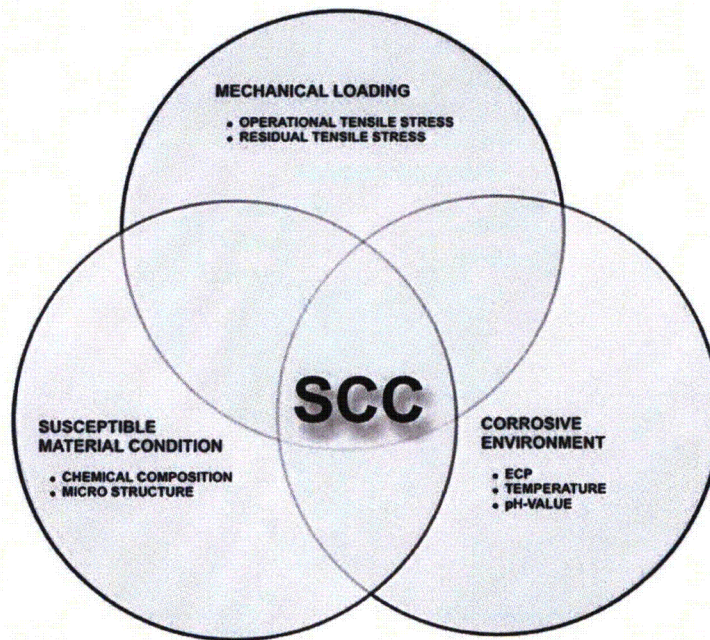
Figure 6: Synergistic Effects Required for Stress Corrosion in Metals

Stress corrosion cracking is a known phenomenon that occurs in Alloy X-750 nickel alloy components under specific conditions. Figure 6 below shows the conditions that need to be present for SCC to occur. SCC will not occur if any of these three factors is out of range of susceptibility. In the case of the D.C. Cook Unit 1 clevis insert bolts, the bolts failed intergranularly (at the grain boundaries of the metal); thus the failure mechanism being IGSCC. Alloy X-750 bolts have historically failed by IGSCC in PWR primary water environments; a phenomenon also referred to as Primary Water Stress Corrosion Cracking (PWSCC). [[Exhibit 42](#)]

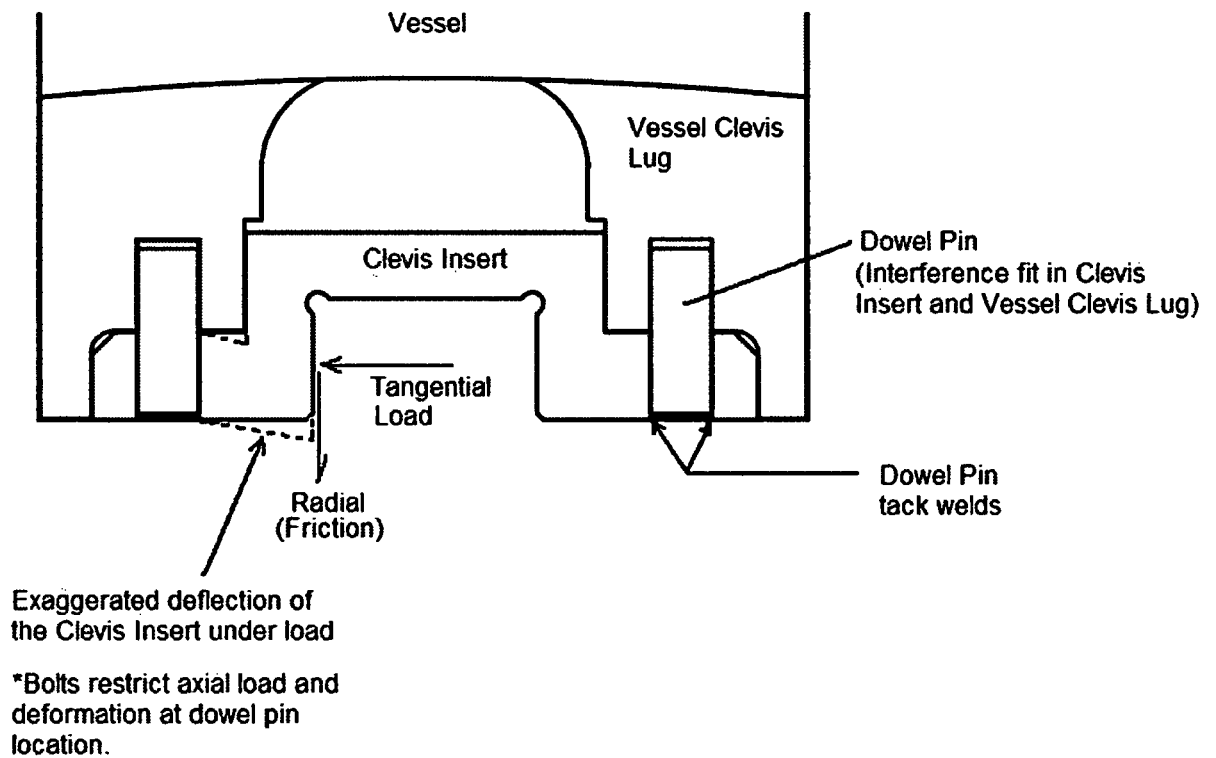
Figure 8: Bolts Intact on Load Side Section A-A

Figure 7 shows an overview of the clevis insert and the location of cross section for the following two figures. Figure 8 shows an exaggeration of how the clevis insert would deflect under radial loading with intact bolts. Figure 9 shows an exaggeration of how the clevis insert would deflect under radial loading with failed bolts [Exhibit 94].

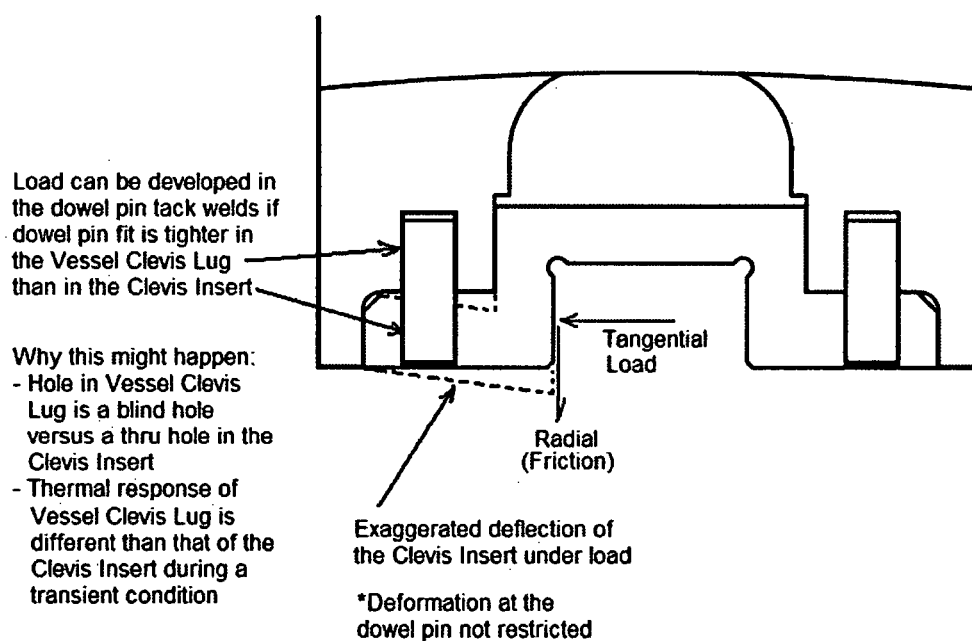
Figure 9: Bolts Broken on Load Side Section A-A

Normal loading of the clevis insert following bolt failure was likely sufficient to drive rotation and axial translation of the dowel pin. The dowel pin must not have been fully seated in the reamed hole at installation which allowed the pin to be driven deeper into the lug. The dowel pin holes were reamed after installation of the clevis insert, so any Poisson burr¹ remnant from machining would tend to ratchet movement of the dowel pin deeper into the hole. Therefore, the failure of the dowel pin tack welds and dowel pin motion is a consequence of the bolt failure at that location.
